Lafayette Avenue Presbyterian Church
Fort Greene, Brooklyn, New York
REPORT OF INVESTIGATION: CEILING
22 February 2024

**Lafayette Avenue Presbyterian Church
REPORT OF INVESTIGATION: CEILING**

LAPC Sanctuary Plaster Ceiling Event

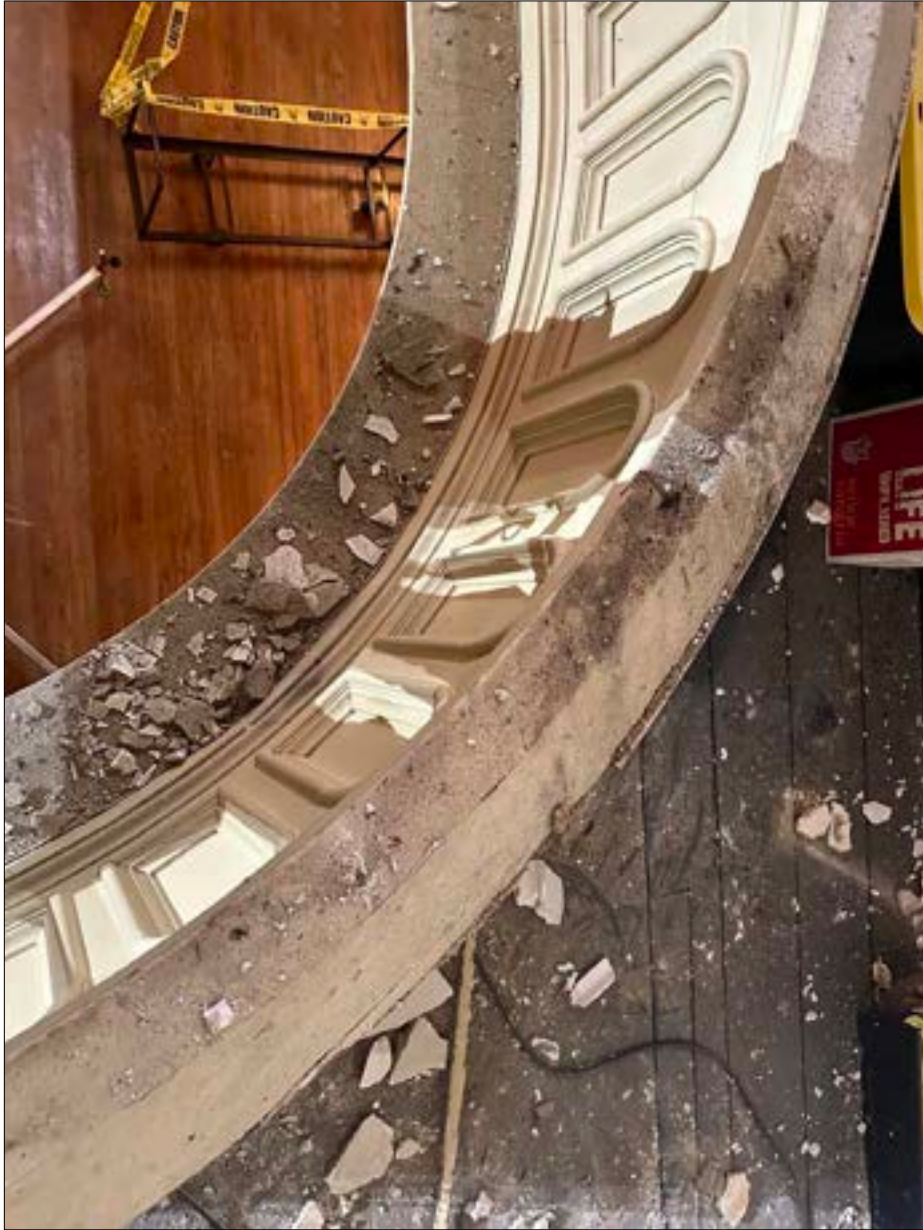
Photo 03. Remnant plaster shards remain scattered in upper reaches of balcony.

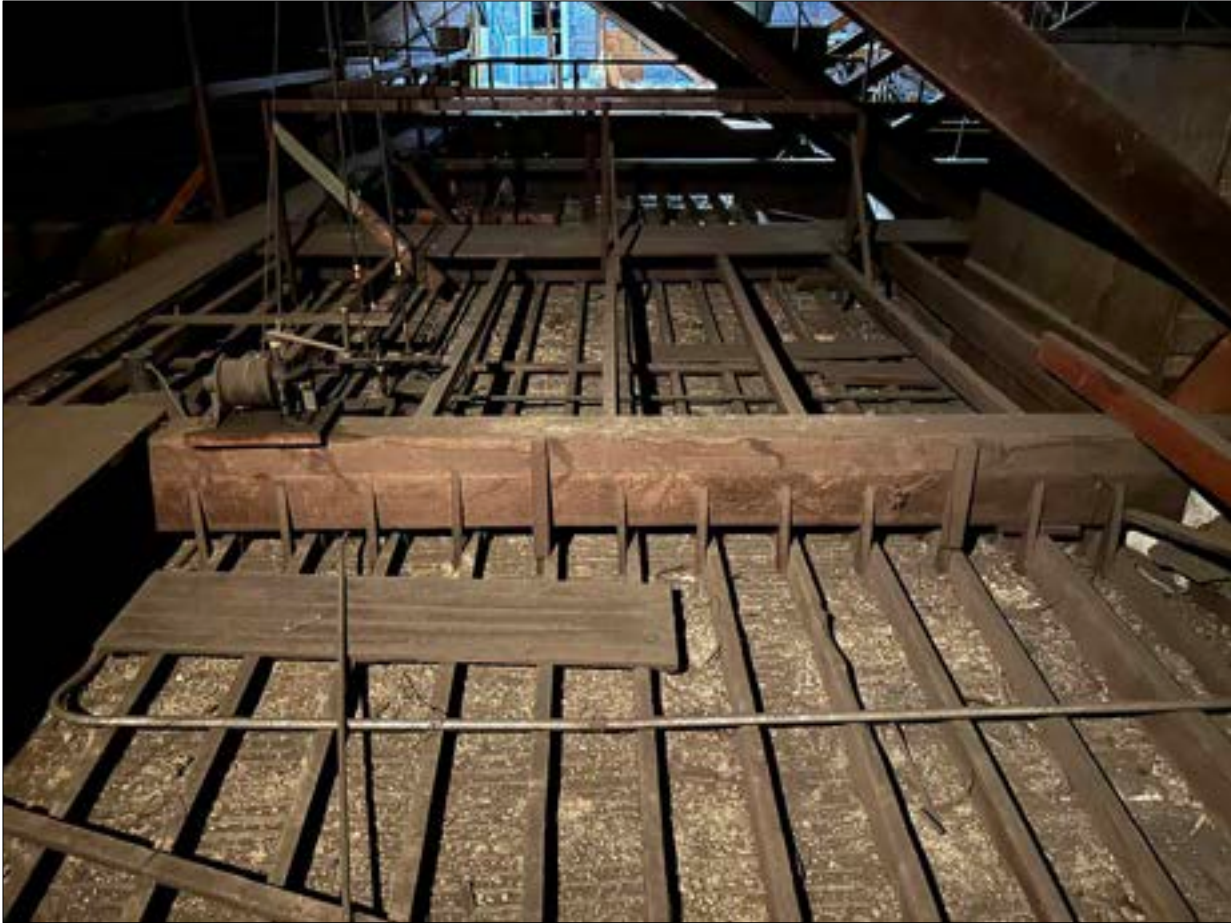
8. Timber trusses supporting struts that in turn support joists to which the plaster and lath are affixed remain in superlative condition. These elements comprise the principal roof framing and structural support of the Sanctuary ceiling. It's worth noting that this particular form of construction is among the best we have ever investigated.

Photo 04. Exceptionally crafted in 1860, the timber & wood framing structural system supporting the ceiling remains in excellent condition; plaster keying through lath, on the other hand, is corrupted in many locations.

7. All uniform flat plaster – whether or not its keys remain intact – will require reattachment to its lath and substrate uniformly, so that gravity-induced loads are distributed evenly across the entirety of the ceiling. Upon completion of this step, extraneous skim coats and peeling paint are removed.

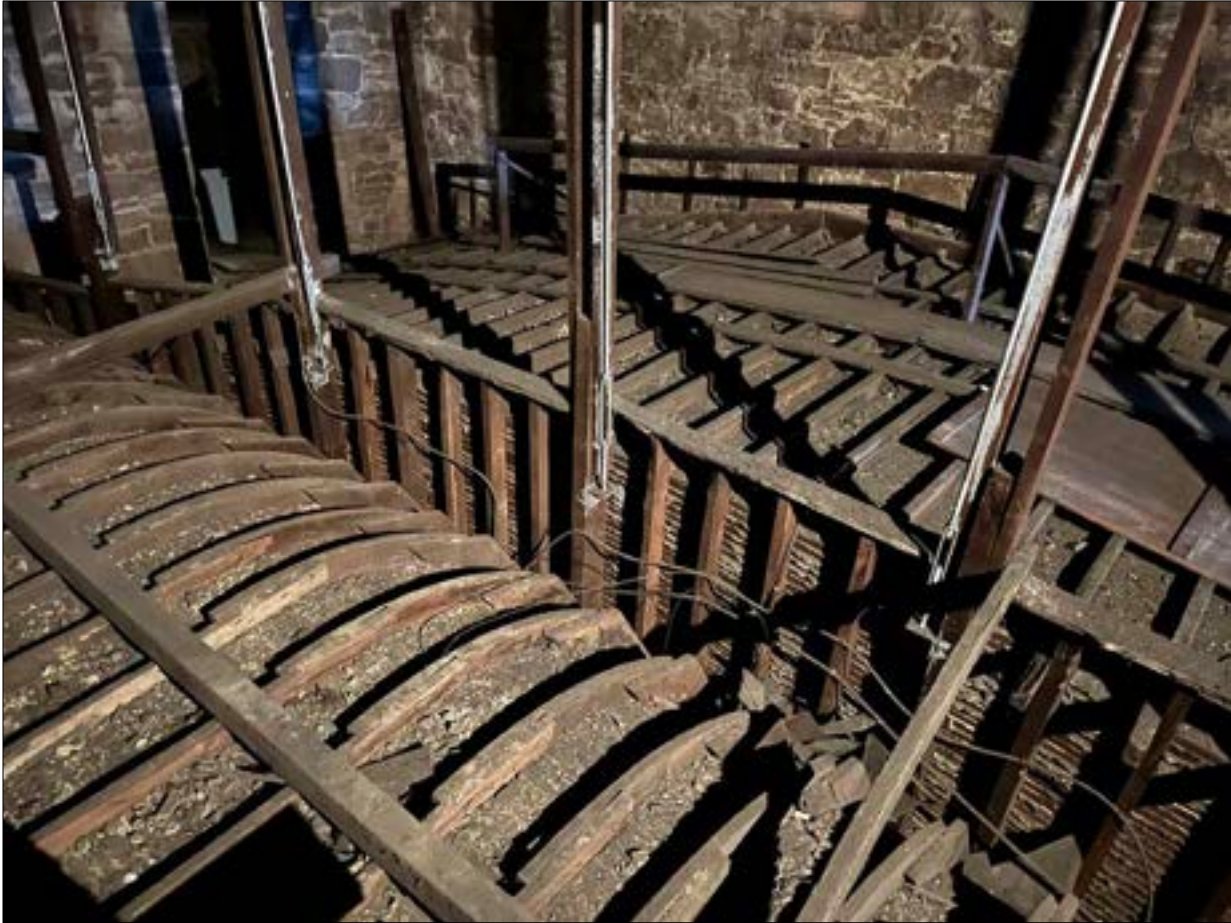
Photo 05. Catwalk over the proscenium arch, where an additional plaster collapse occurred. Concentrated foot traffic in this location renders it more prone to applied forces and, correspondingly, to damage.

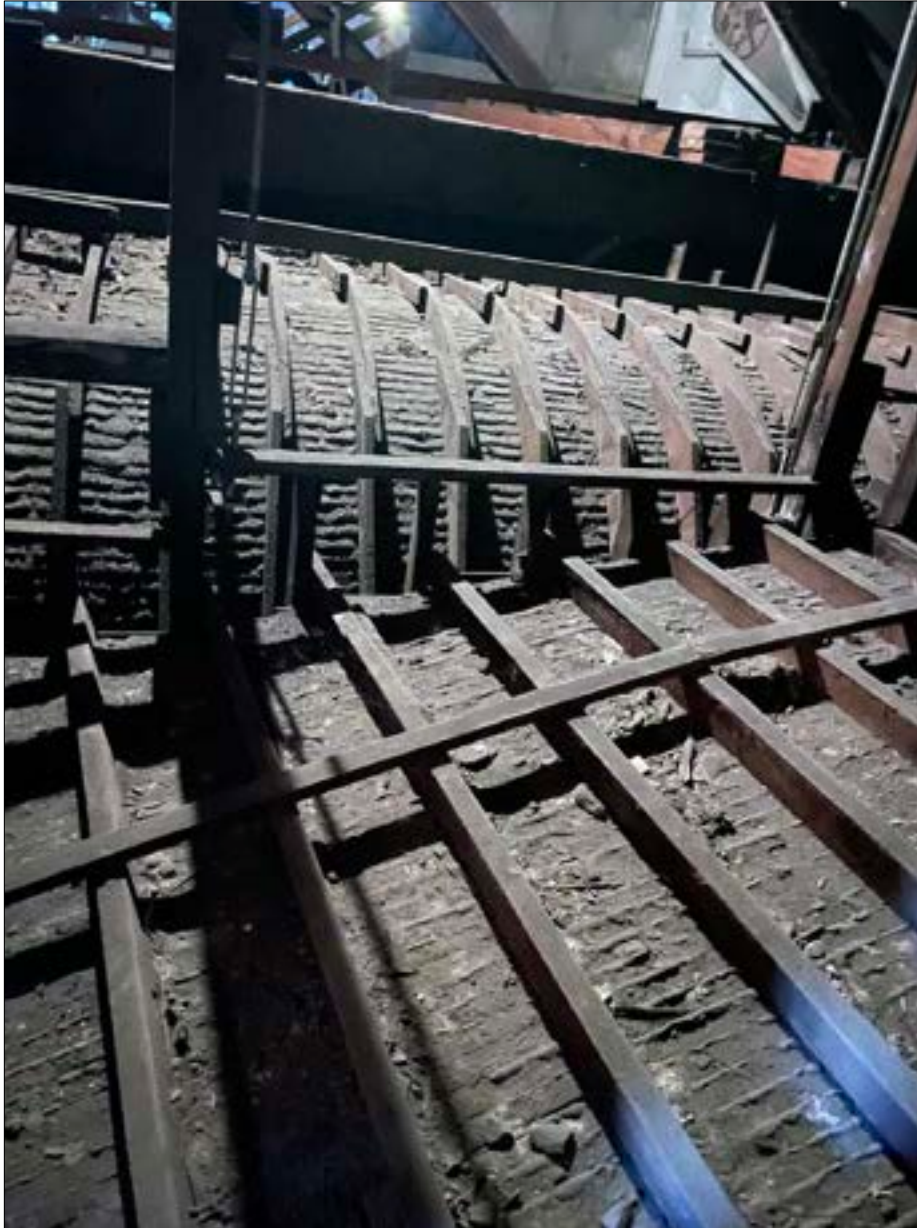
Photo 06. The quality of keying within the covered cornice is clear; its geometry helps to sustain its formidable condition.

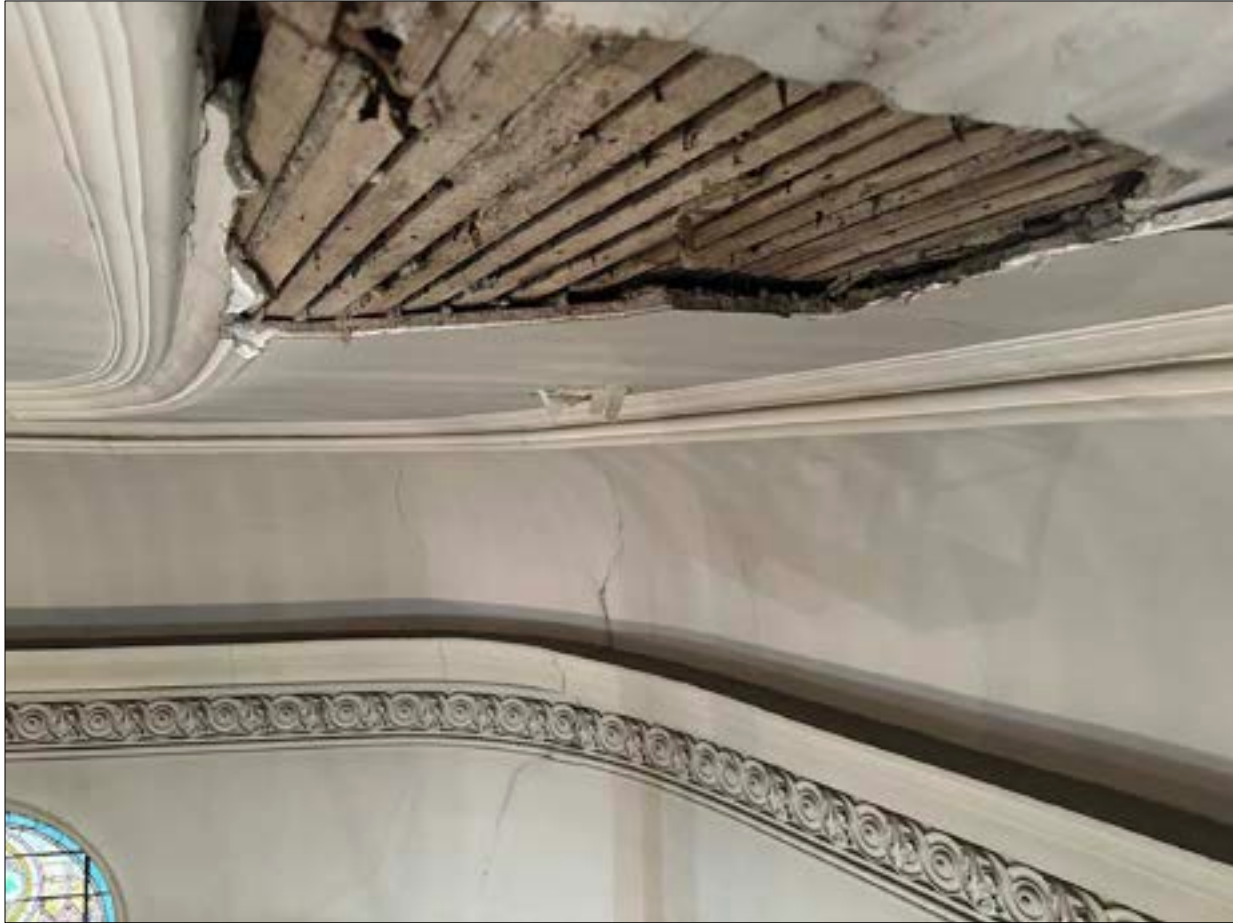
Photo 07. Site of flat plaster failure of August 10-11, 2023, located in the southeast quadrant of the ceiling, above the cove and just east (left) of the organworks.

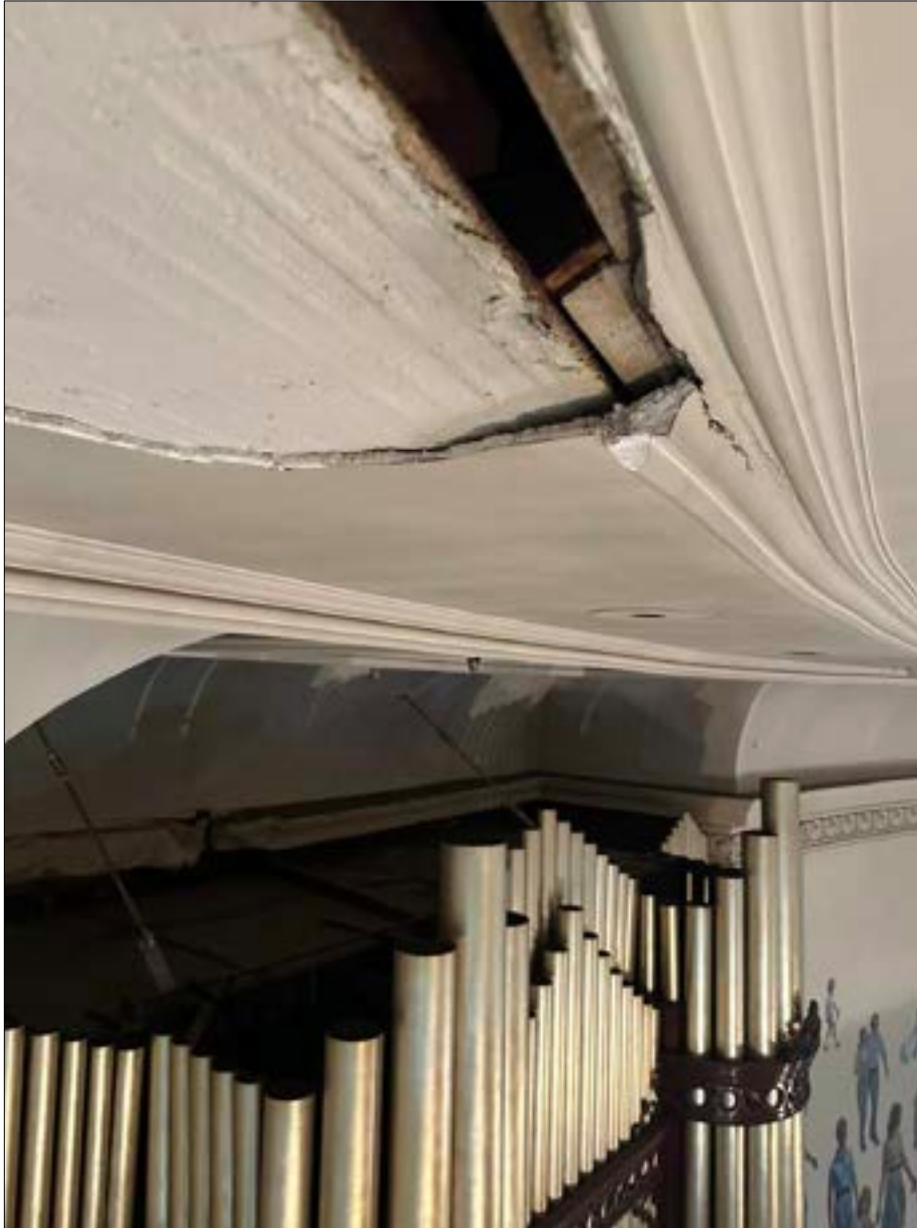
Photo 08. Detail of failure looking west toward organ. The white plane of material represents a flow coat of adhesive applied when the high-hat light fixtures were installed, likely because cracking was evident in the area of the intervention.

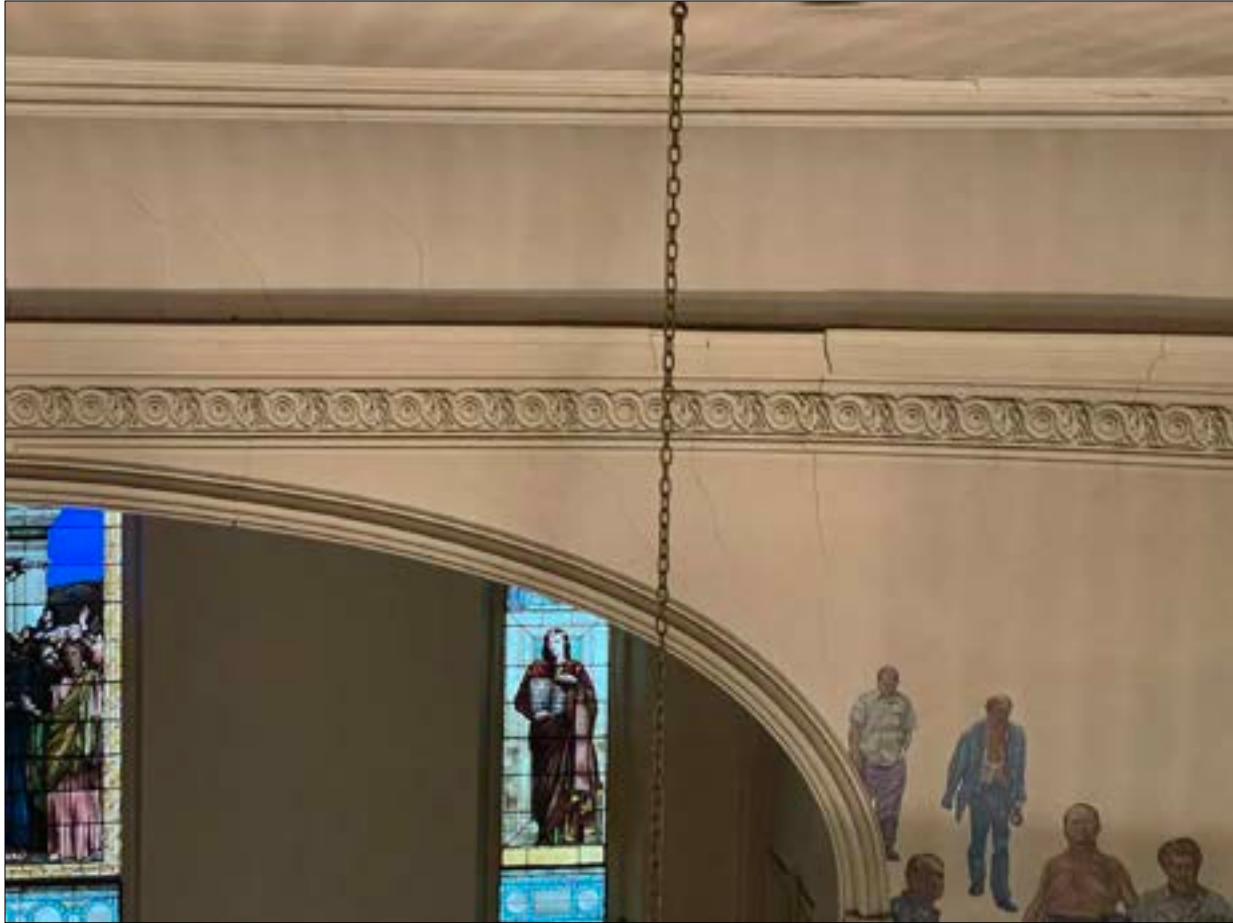
4. Exterior roofing & flashing leaks contributed to cracked and dislodged (though not fallen) molded elements comprising the perimeter cove; recent work on the roof drainage system has corrected the primary source of affected locations in proximity to the steeple and Pastor's Study towers in the northwest and northeast corners, respectively.

Photo 09. Dislodged molding at belt course above mural and leaded glass. The source of this damage is water penetration at the tower of the Pastor’s Study, which has been restored as a result of the “Opening Doors” campaign. This – and other – large plaster sections are completely disengaged from the wall system.

9. Cracked and dislodged running molding (e.g., that which comprises the upper cove and the band course above the mural and leaded glass windows) may be removed and re-attached, once the underlying cause of their disturbance has been corrected and the substrate is stable.

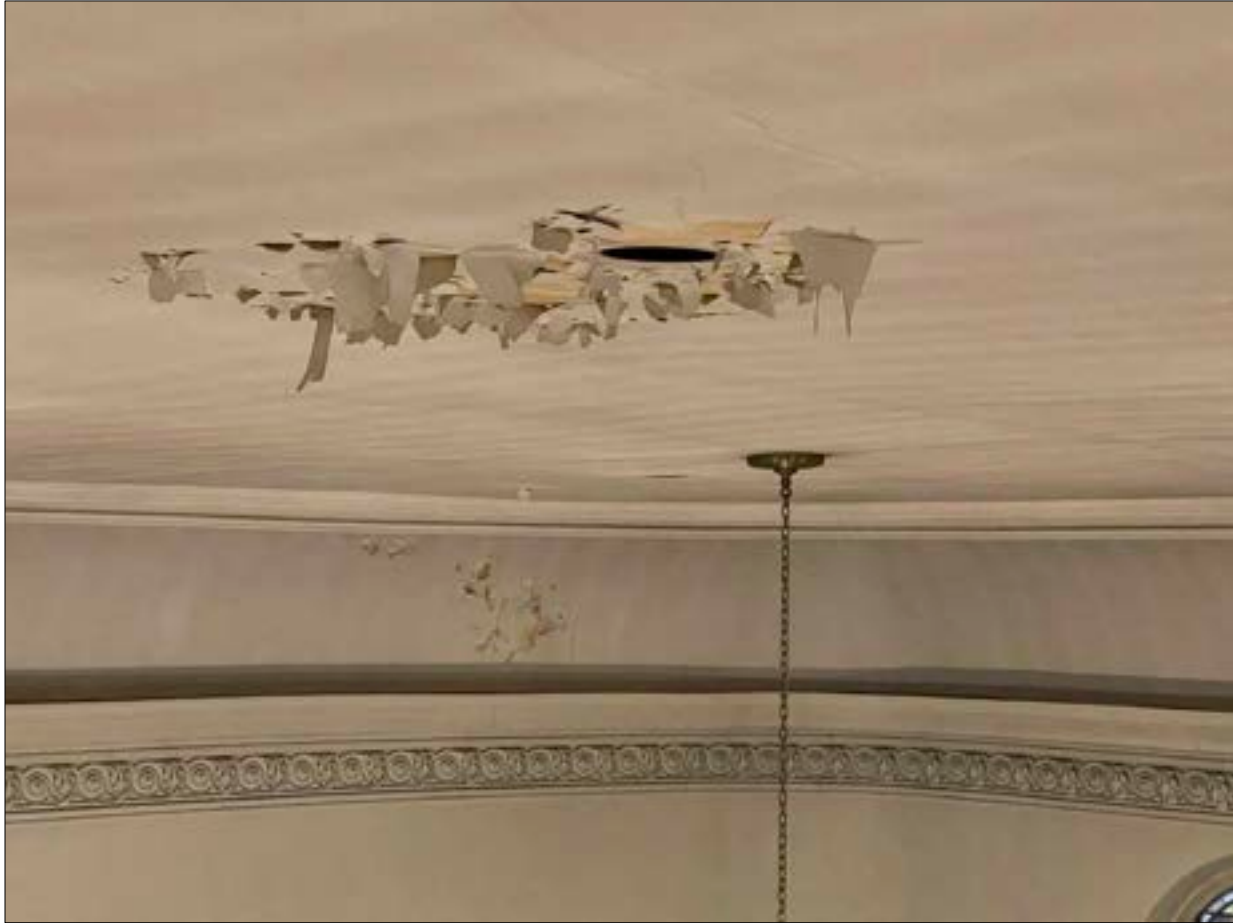
6. The interposition of relatively modern downlights ("high hats") consistently is the cause of much localized cracking, presumably resulting from the vibration of equipment used to cut holes for the lights and the presence of people applying unintended loads to the plaster and lath around each installation. *It's notable that the fallen plaster was in direct proximity to just such a light fixture.*

Photo 10. Damage is clearly apparent in the vicinity of all high-hat light fixtures. Reasons include unintended air passage, extreme drying-out because of their heat, and physical damage resulting from their installation.

5. A refined lighting plan should precede this work, allowing for selection of appropriate new fixtures, armatures, and controls. All non-original light fixtures mounted within the plaster surfaces should be removed.

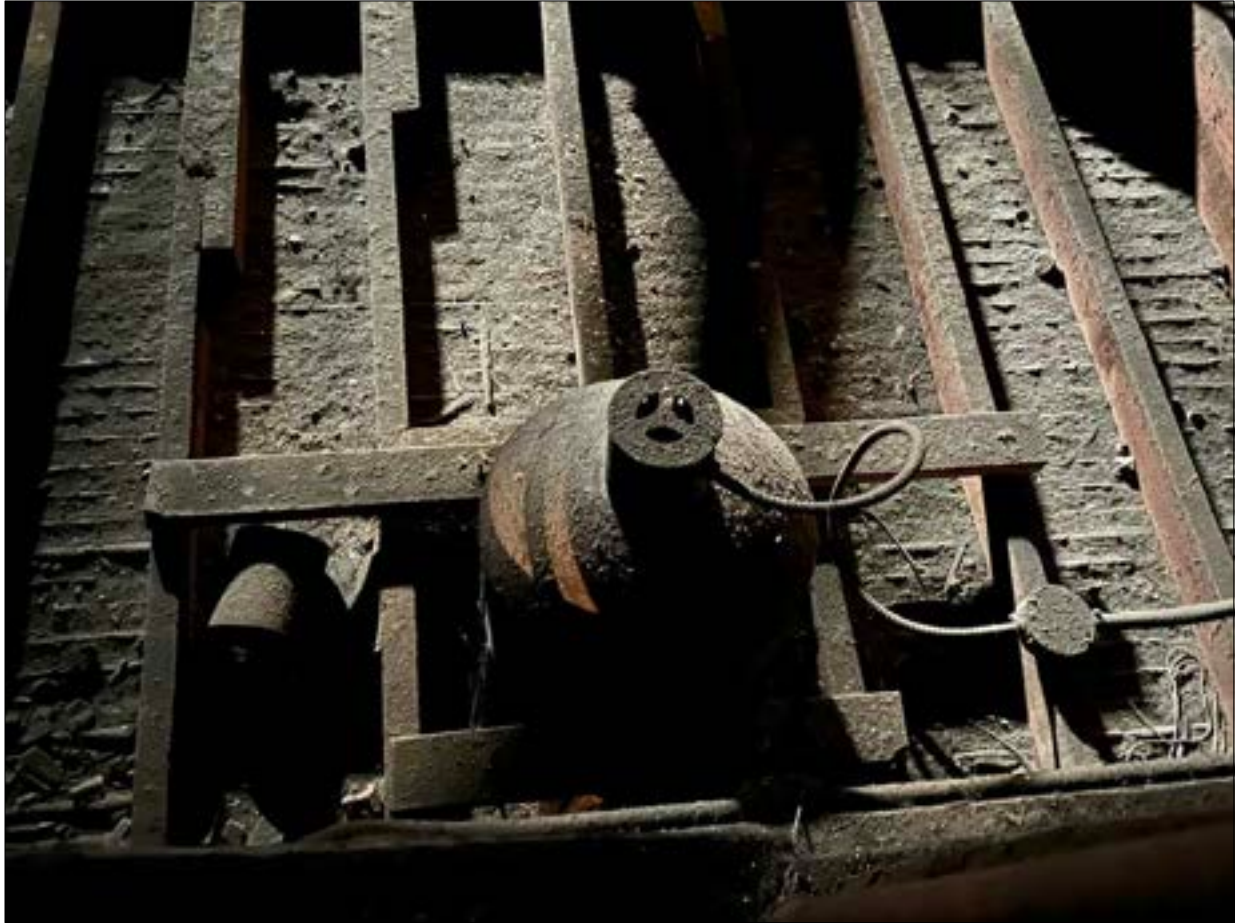
Photo 11. Installation of a high-hat light fixture from above, viewed from within the attic.

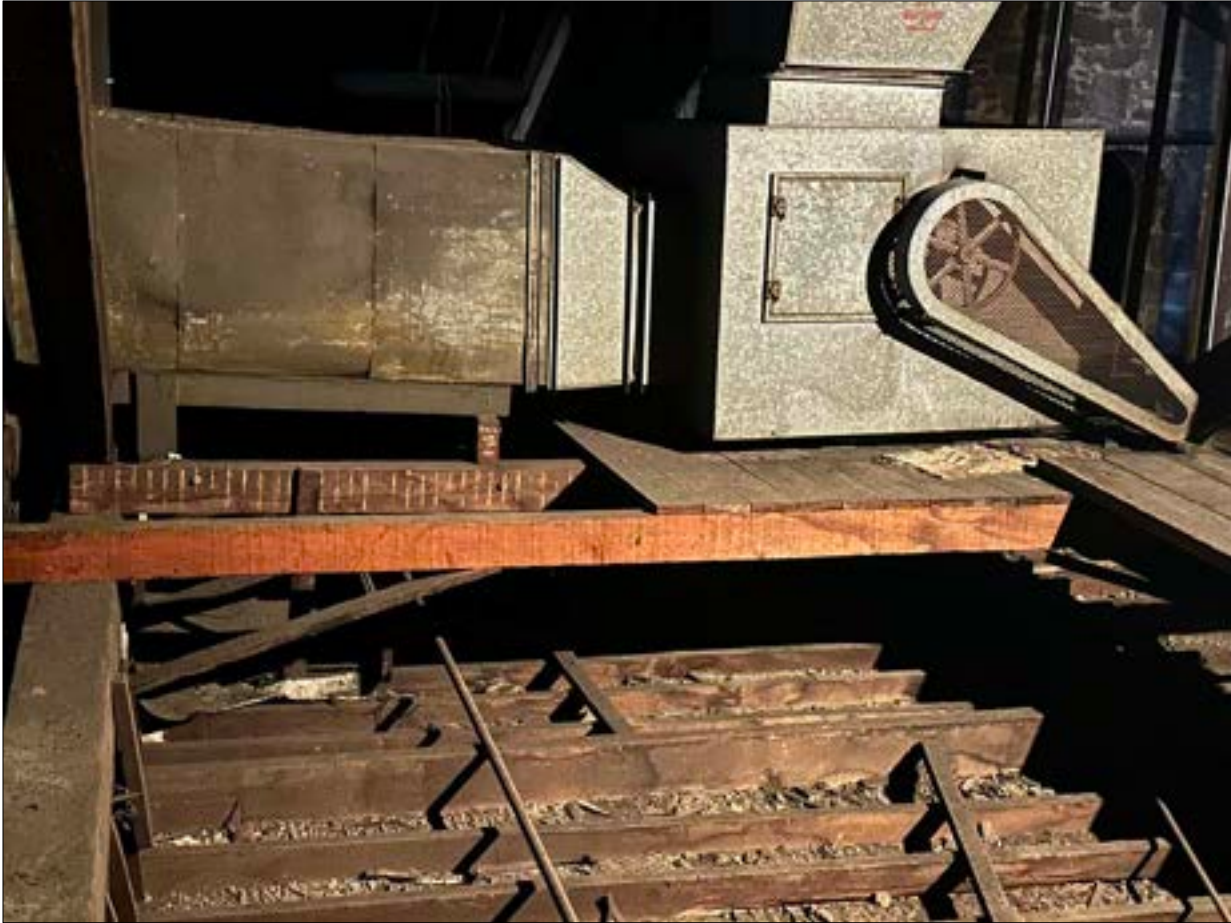
3. Compounding the issue above are the belt-driven motors and fans designed to move air, which are determined as non-original because they are electric, and the Church's construction pre-dated the arrival of electricity in New York by more than two decades. The action of the motors presents a significant source of high-frequency vibration, which would negatively affect plaster keying.

Photo 12. Installation of mechanical equipment introduces a significant level of vibration never intended for this structural system. Aside from drawing large volumes of concentrated air (vs the ambient, more gentle, convective heating/cooling of the 1860s design) inflexible ducted systems present myriad negative issues.

6. Mechanical interventions should include remote fans for attic ventilation (i.e., not directly mounted to the perimeter framing of original air vents) and fire suppression, as well as more uniform ambient lighting to facilitate safer and more periodic inspections.

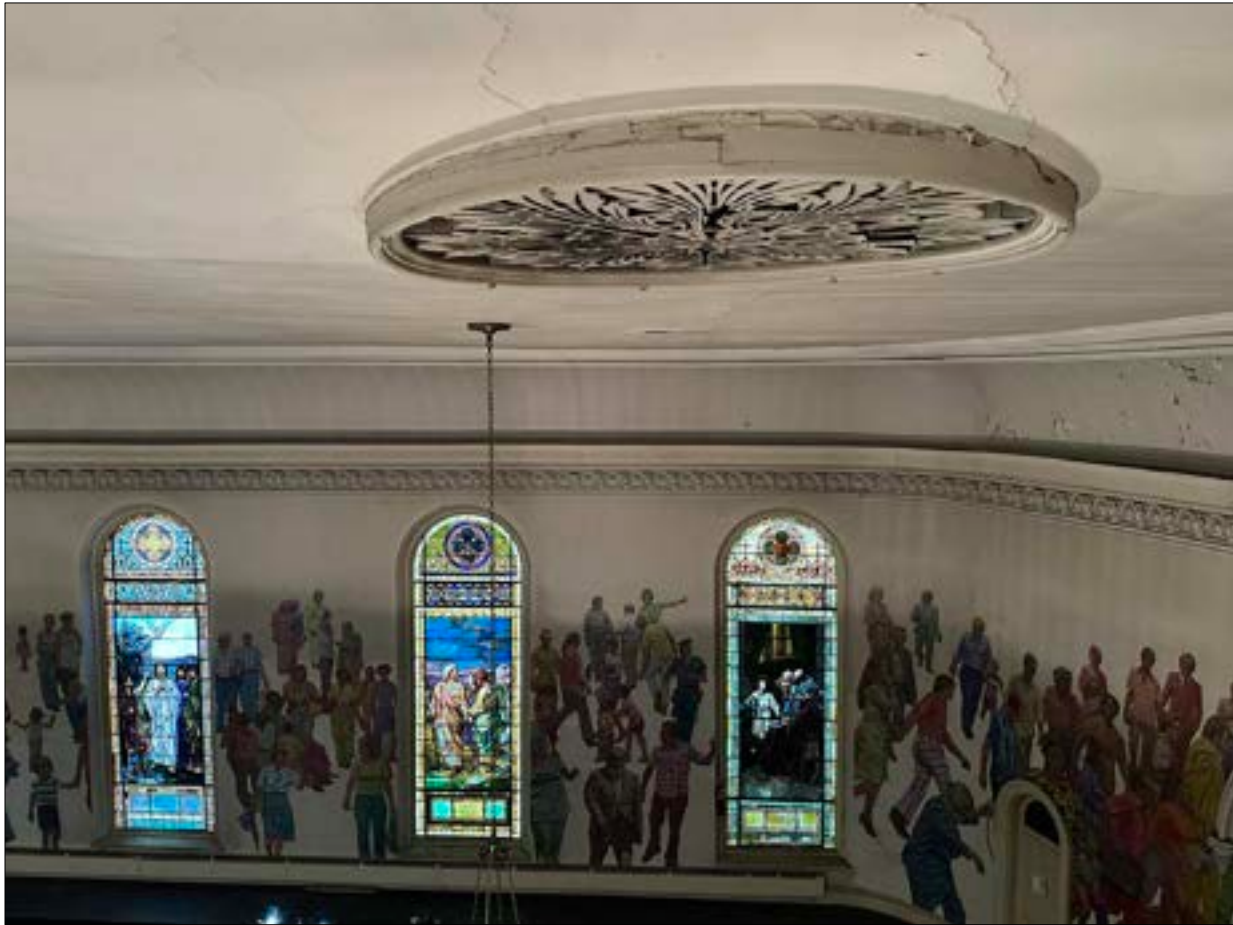
2. Deterioration around the air vents is directly attributable to the designed ventilation system of the Church; that is, large volumes of air – hot and cold, wet and dry, depending on the season and external atmospheric effects – are in constant contact with the open edges of plaster around the perimeters of the decorative vent registers, or screens. Mostly, these surfaces would have been adequately protected when painted; over time, though, the paint erodes and plaster is exposed. Clearly, as a casualty of its height and scale, the ceiling has not been painted often.

Photo 13. One of three targeted terminals of the ducted system above, deformation and other damage was clearly evident during the last painting campaign, 50-70 years ago. It's gotten worse.

10. Molded rosettes and decorative grilles defining the three central vents will be protected, encased and removed in their entirety, allowing restorative processes to take place in a shop (or within the Church, if a pop-up field shop is a possibility). Restored rosettes may be safely and permanently re-adhered once restored. Grilles will require more deliberation, once fully removed, to determine the optimal course of action (i.e., restoration or re-fabrication in an alternate material).

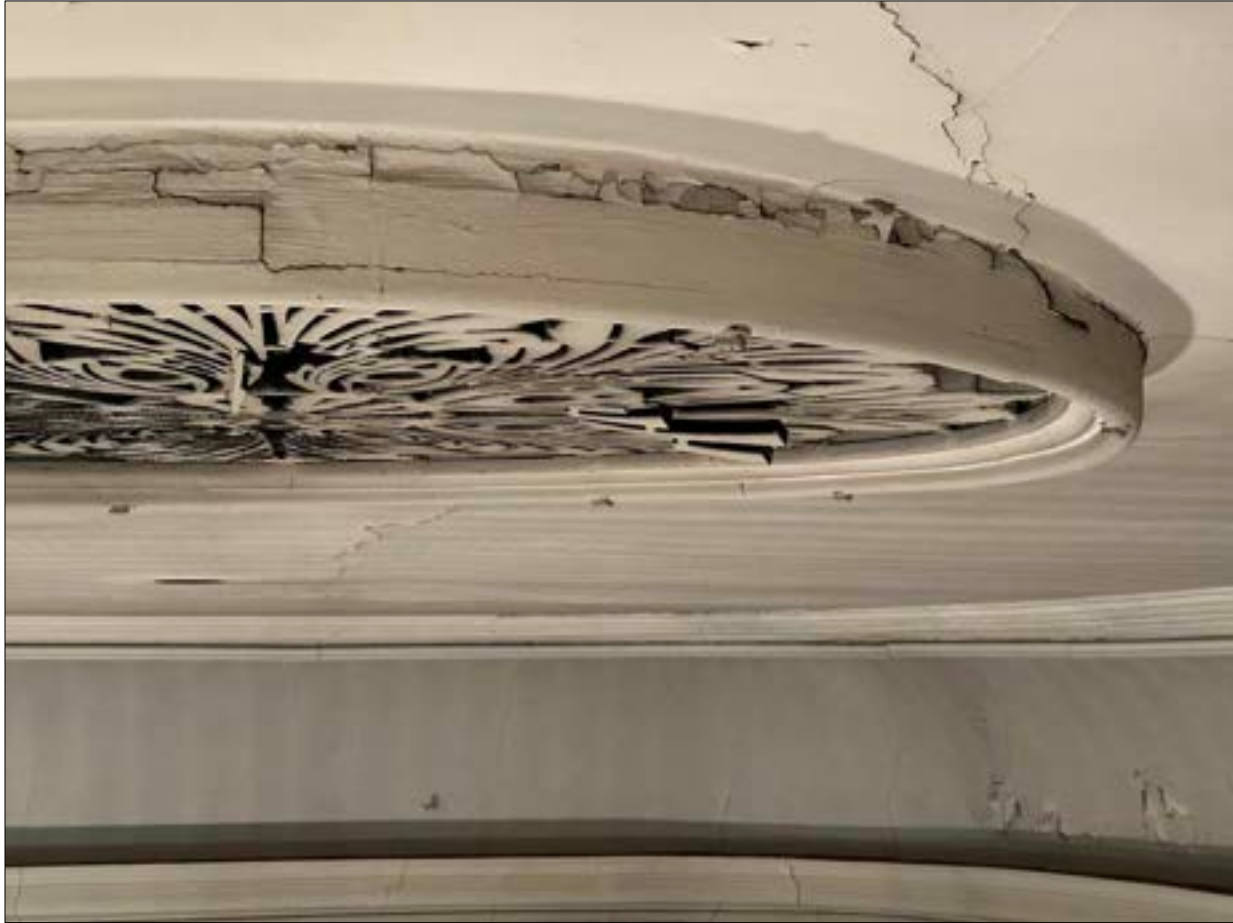
Photo 14. Detail of the molded medallion and vent grille in Photo 13. Note the buildup of infill material applied during the last painting project; this feature was already in a failure mode then.

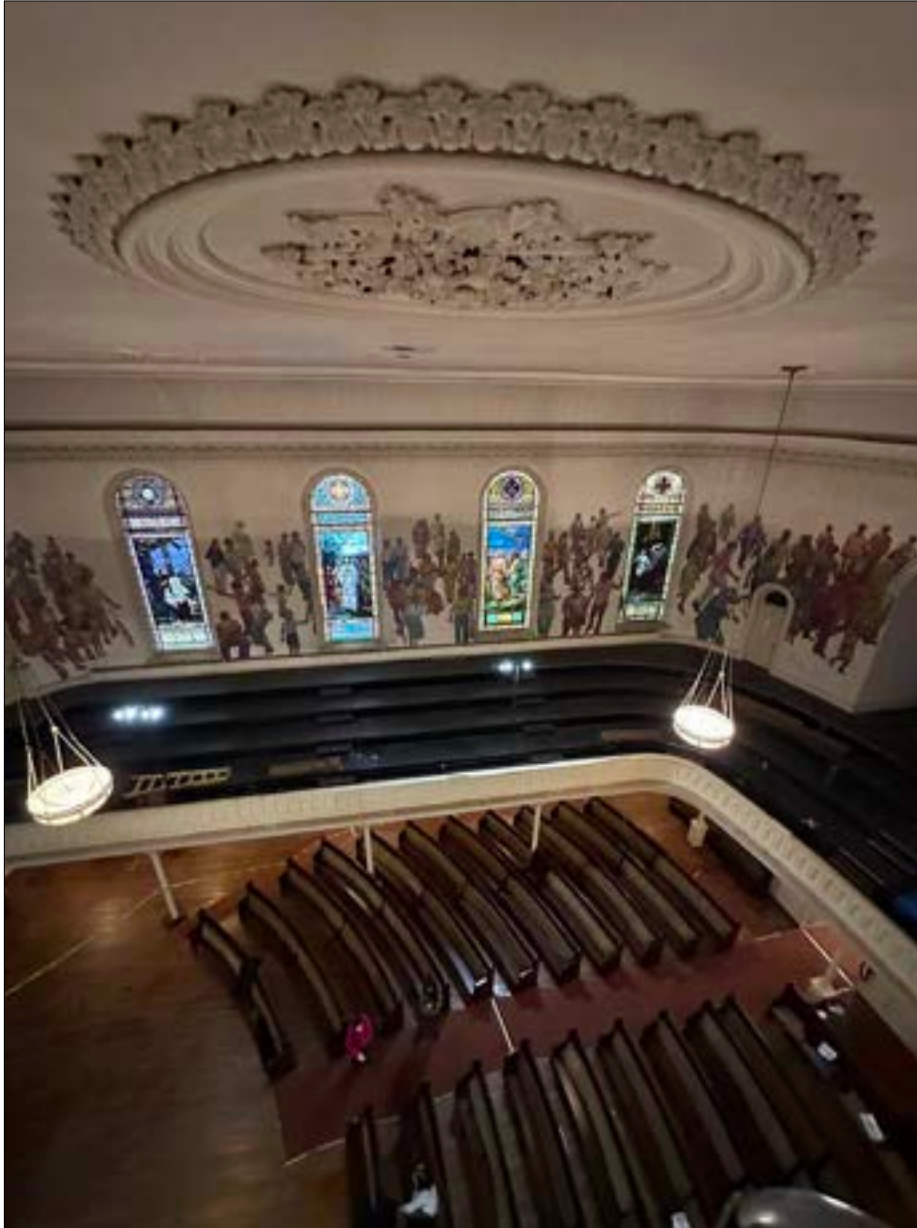
Photos 15. Studies of deterioration pathologies highlight worst conditions by definition. It's also important to recognize that the vast majority of the ceiling remains in very good condition.

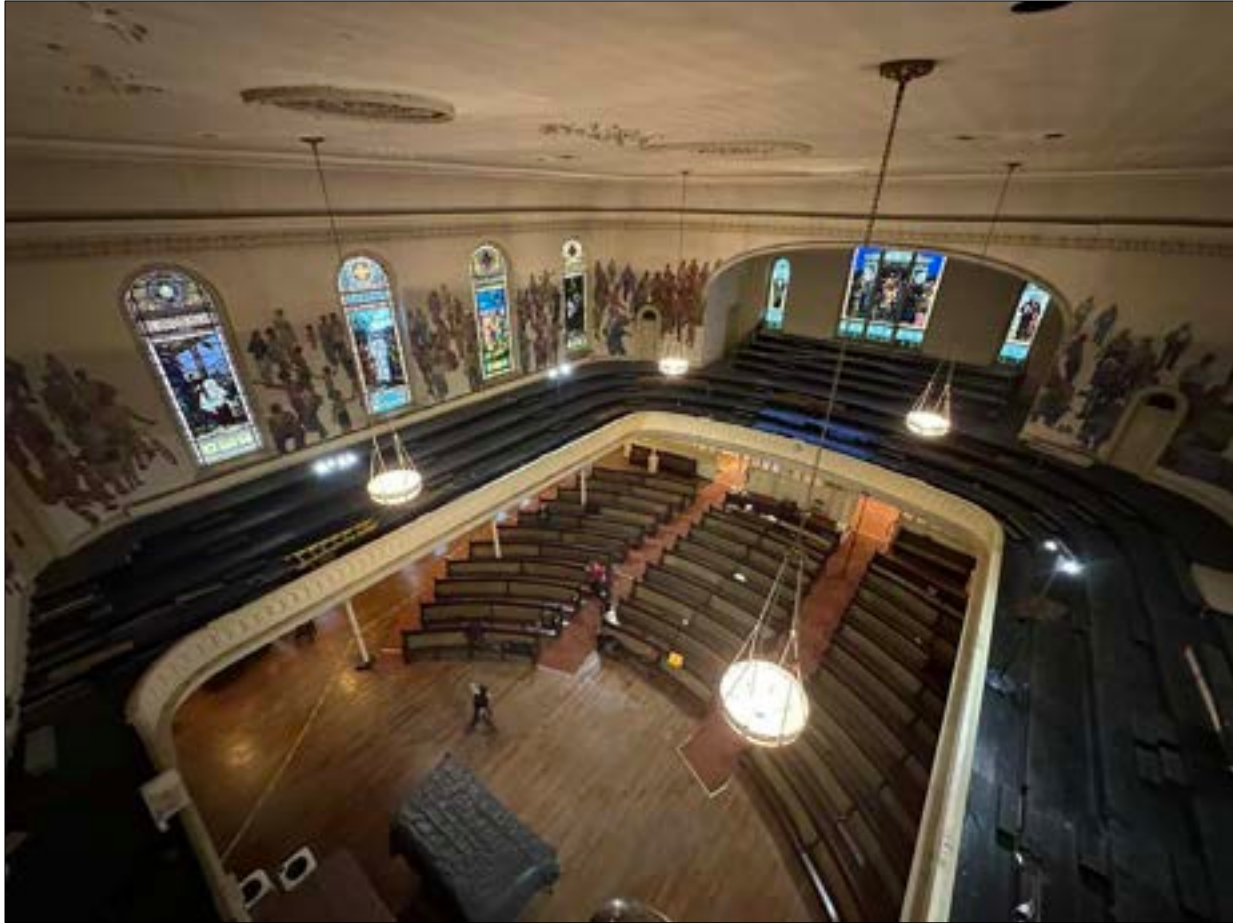
Photo 16. A view across the ceilingscape supports the notion that this ceiling remains a remarkable remnant of an exemplary period of building and construction technology, notwithstanding current maladies that are now far better and more precisely understood, categorized and restorable.
