Lafayette Avenue Presbyterian Church
Fort Greene, Brooklyn, New York
REPORT OF INVESTIGATION: CEILING
22 February 2024

**Lafayette Avenue Presbyterian Church
REPORT OF INVESTIGATION: CEILING**

LAPC Sanctuary Plaster Ceiling Event

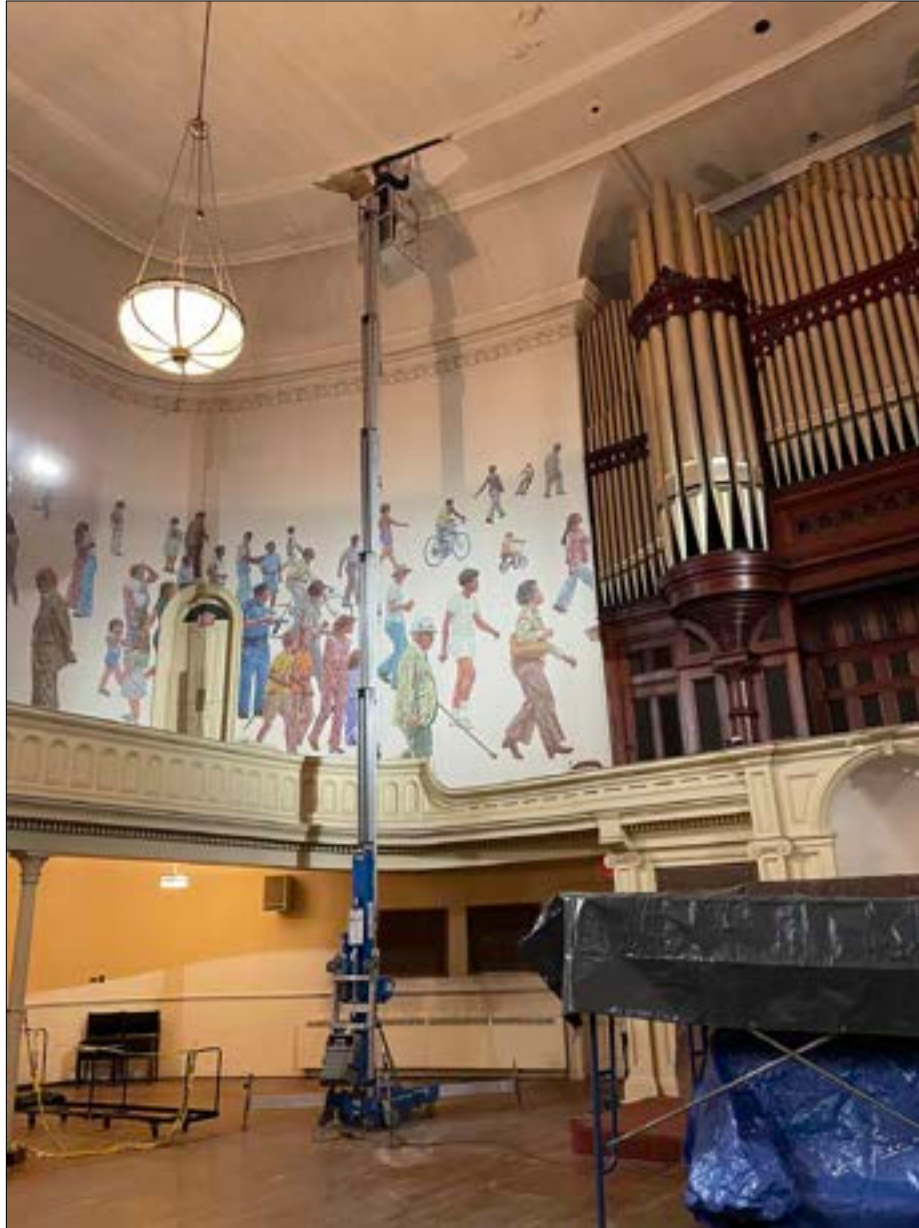
Photo 02. Detail of personnel lift allowing direct access for hands-on inspection.
