Lafayette Avenue Presbyterian Church
Fort Greene, Brooklyn, New York
REPORT OF INVESTIGATION: CEILING
22 February 2024

**Lafayette Avenue Presbyterian Church
REPORT OF INVESTIGATION: CEILING**

LAPC Sanctuary Plaster Ceiling Event

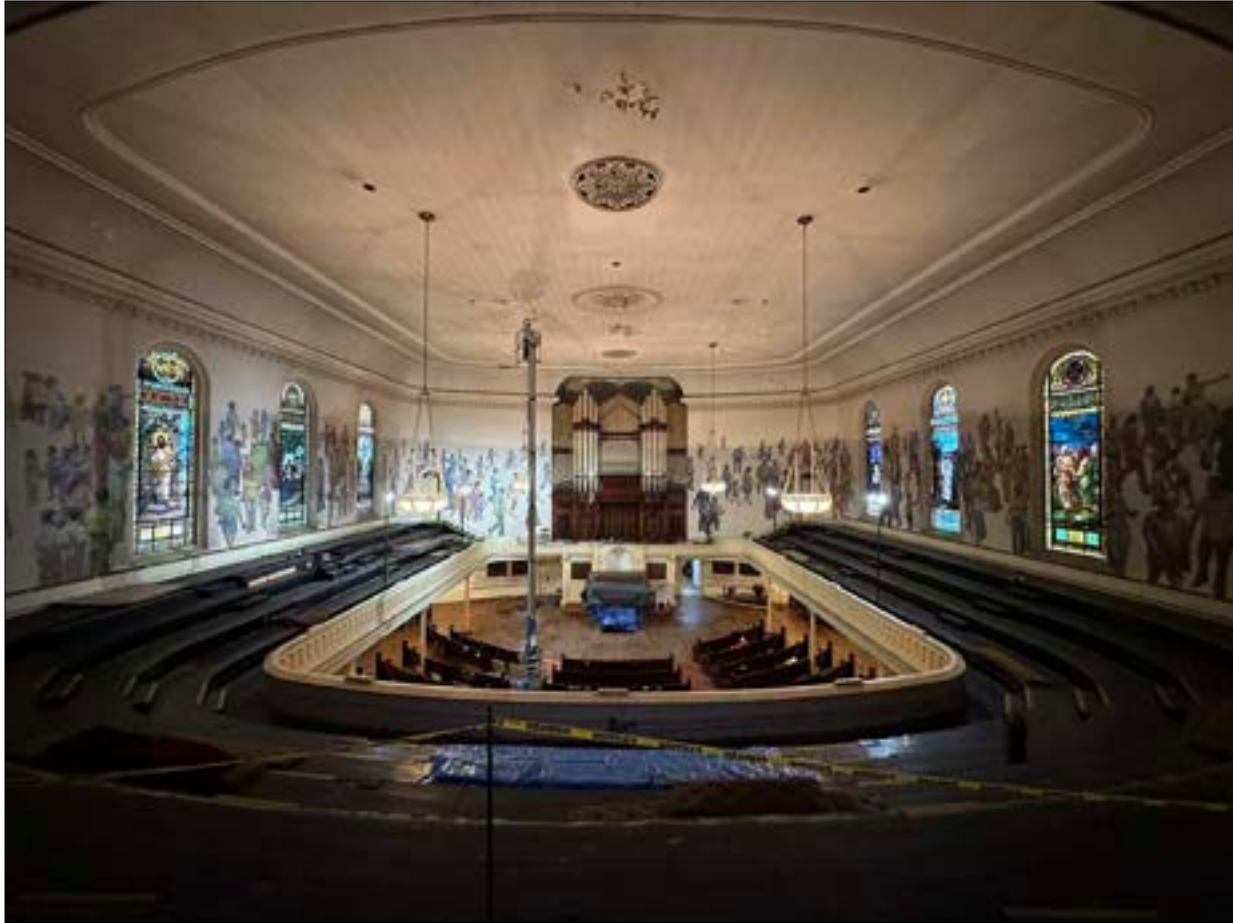
Photo 01. Overview of ceiling and survey methodology, looking south from choir loft.
